## Inspection Report

**Property Address:**  
8805 Sample Way  
Louisville, KY 40222

**ProChek Home Inspections, LLC**

<b>Date:</b> 12/1/2013	<b>Time:</b> 3:00 PM	<b>Report ID:</b> 2013-777Sample
<b>Property:</b> 8805 Sample Way Louisville, KY 40222	<b>Customer:</b> Sample Sample	<b>Real Estate Professional:</b>

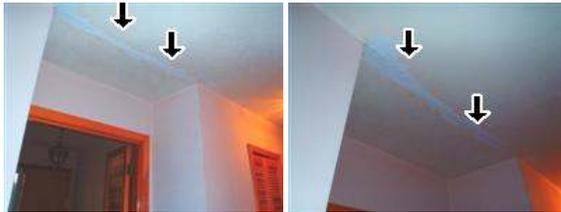
Ceiling has been patched in the foyer and master bedroom.

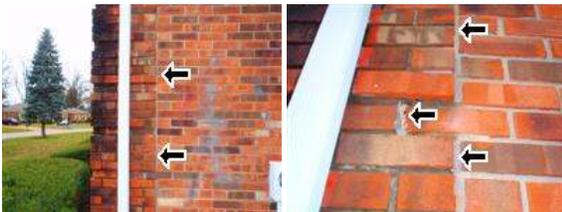
Some settlement has occurred at the right front corner of the house. The loose mortar joints have been caulked. The area shows no further settlement since the cracks were sealed, indicating the settlement has stopped. The nature of these cracks are not severe enough that any further evaluation is needed at this time.

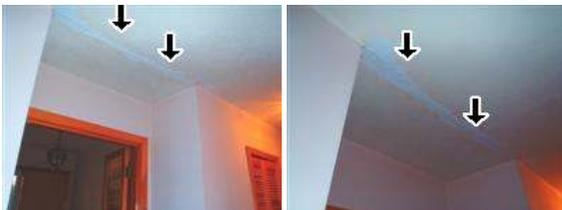
Ceiling has been patched in the foyer and master bedroom.

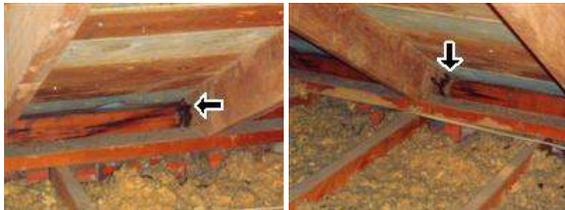
**10.5 ROOF SHEATHING****Information only**

Stains were present but were dry at the time of the inspection.
